RAILWAY INVESTIGATION REPORT

R03V0083

MAIN-TRACK DERAILMENT

Canadian National
Train No. 356-51-14
Mile 7.9, Fraser Subdivision
McBride, British Columbia
14 May 2003

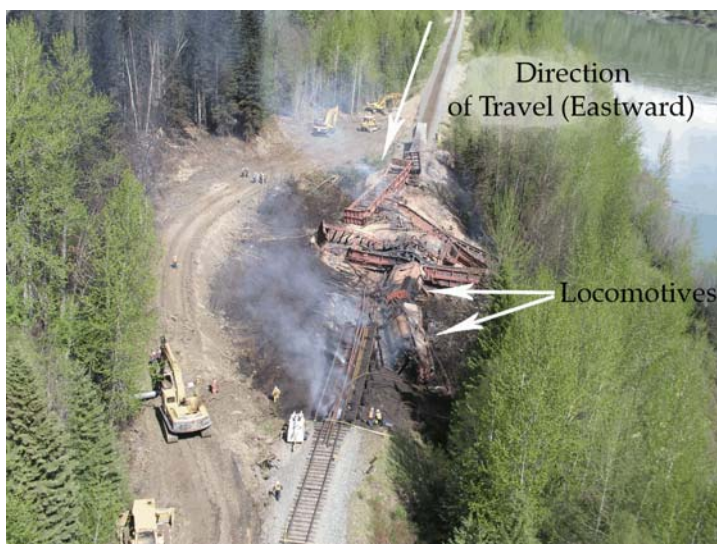
Photo 1. Occurrence site

The locomotives toppled off the bridge, dropping approximately 25 feet into the gully below (see Photo 1). The following three cars were piled perpendicular to the centre line of the bridge. The first car behind the trailing locomotive came to rest across the cab portion of the trailing locomotive. The top portion of this locomotive's cab was torn off. The fourth car stopped in an upright position toward the west dump wall of the bridge. The fifth car was derailed, but remained upright on the west approach of the bridge.

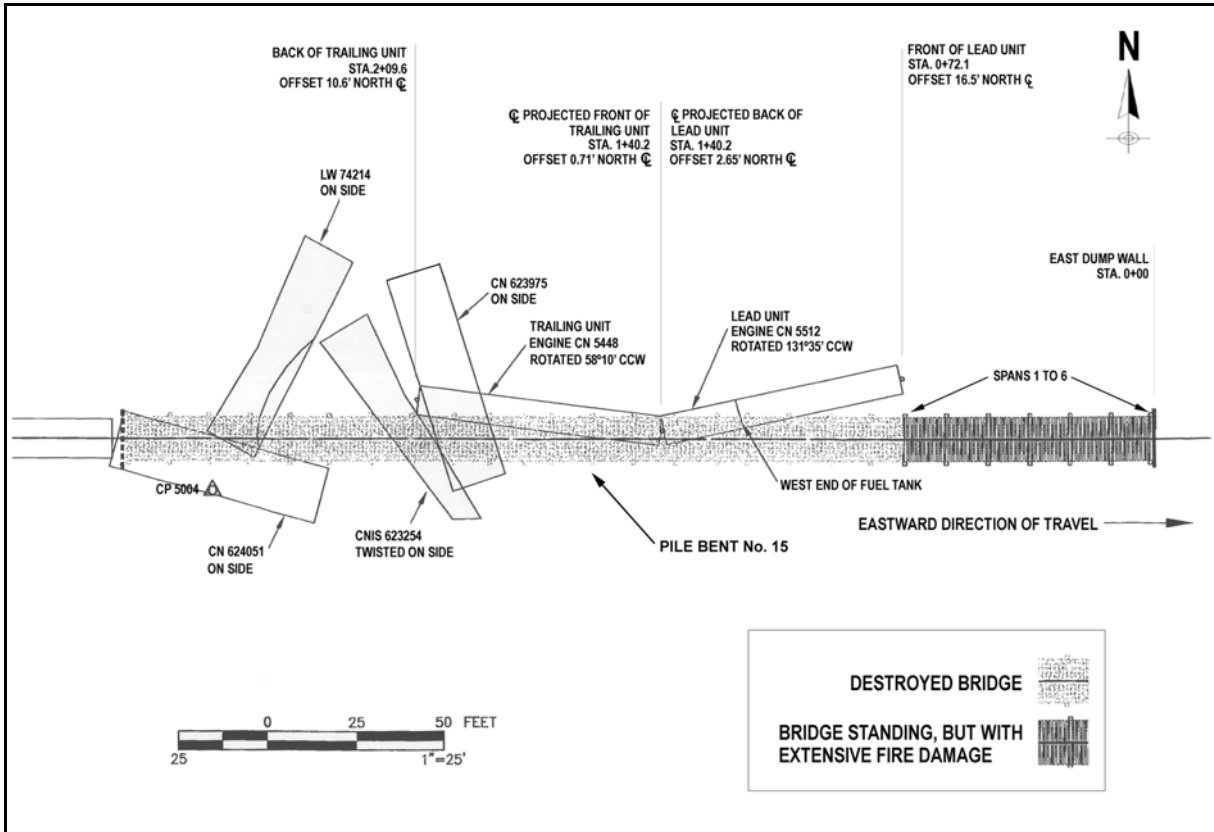
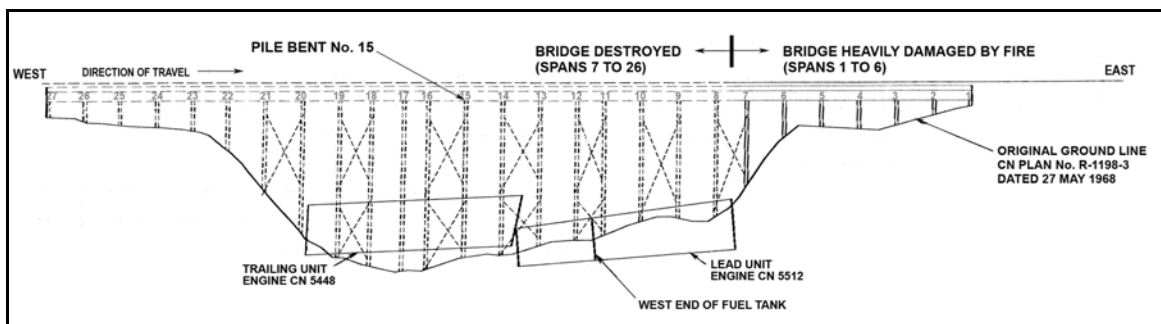
Figure 3. Derailment site plan

The west end of the bridge (spans 7 to 26) was destroyed during the derailment and the fire that followed. Approximately 65 feet of the east end of the bridge (spans 1 to 6) remained standing, but were damaged by the fire (see Figures 3 and 4).

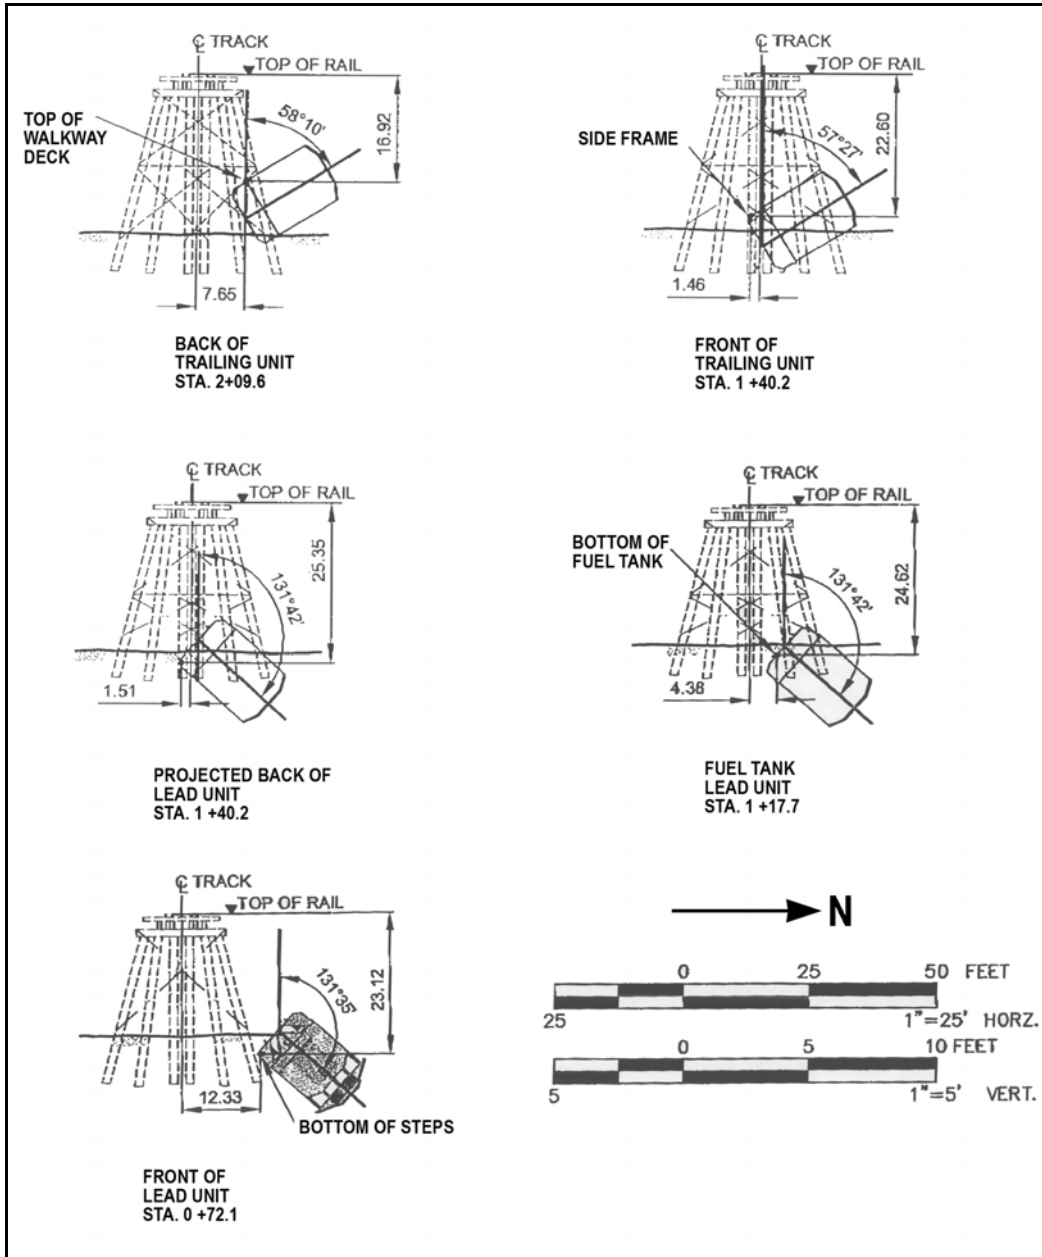
Figure 5. Resting positions of locomotives

The two locomotives came to rest between bents 7 and 20 near the centre line of the bridge. They were coupled rear to rear. Measurements of their final resting positions were taken relative to the centre line of the bridge and are shown on the diagram (see Figure 5). The front end of the lead locomotive was 72 feet from the east dump wall and the end of the trailing locomotive was 210 feet from the east dump wall. The lead locomotive had rotated through 131 degrees from the upright position, coming to rest on the bank of the gully. The trailing locomotive rotated through 58 degrees.

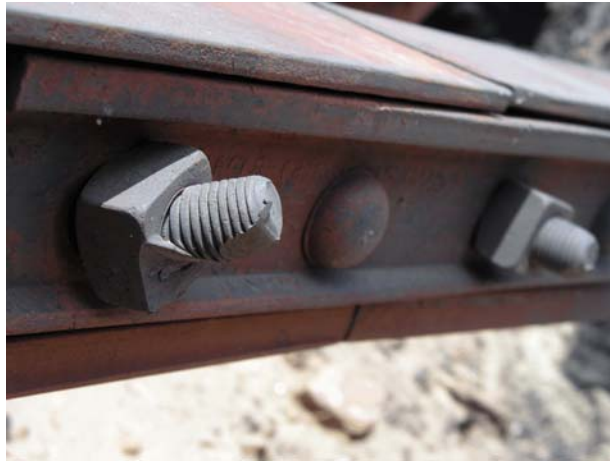
Photo 3. Impact mark on the guard rail splice bar bolt

The running rail and guard rail were found hanging from the remaining portion of the bridge, twisted and tangled within the wreckage. The rails were broken in several pieces at the west end of the bridge. Scrapes and impact marks (see Photo 3) on the side of the south guard rail and on the head on the north guard rail indicate that the lead locomotive had contacted the guard rails approximately 145 feet from the east dump wall.
